Rolling Bearing Damage

Recognition of damage and bearing inspection

Publ. No. WL 82 102/2 EA

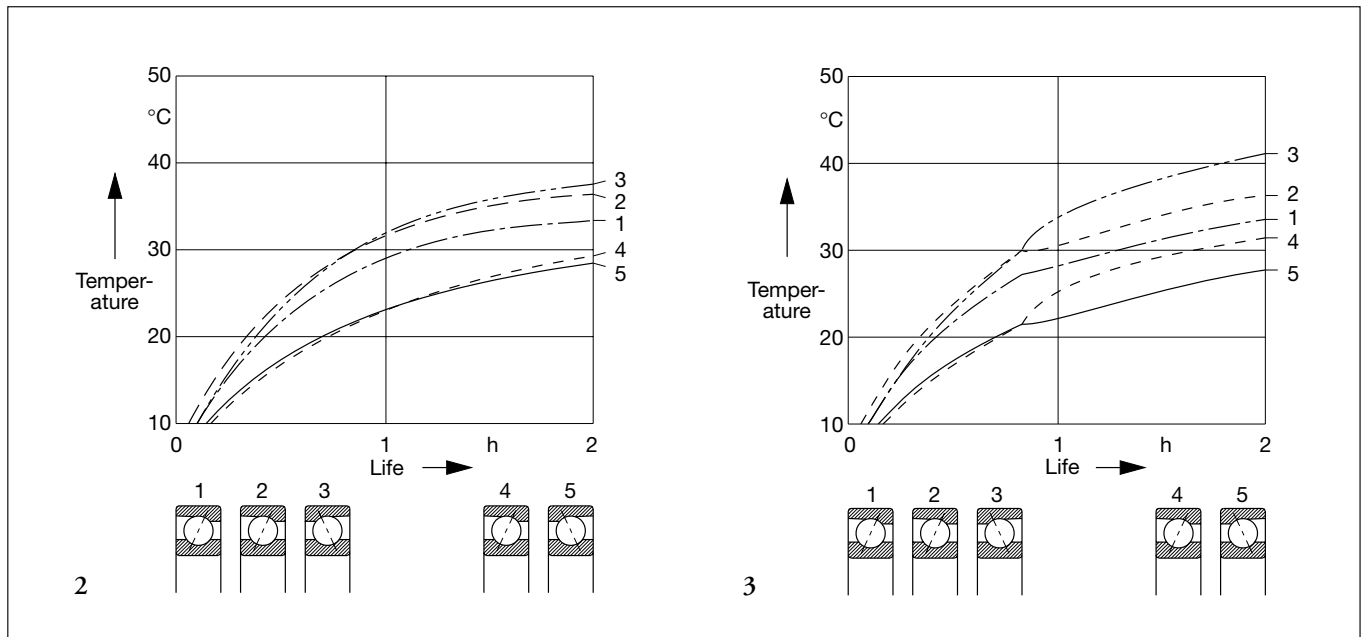
3: March of temperature with disturbed floating bearings. Test condition: $n \cdot d_m = 750\,000 \text{ min}^{-1} \cdot \text{mm}$.

- sudden rise in temperature caused by lack of lubricant or by the occurrence of excessive radial or axial preload on the bearings, fig. 3.
- uneven march of temperature with maximum values tending to rise due to general deterioration of lubrication condition, e.g. with attained grease service life, fig. 4.

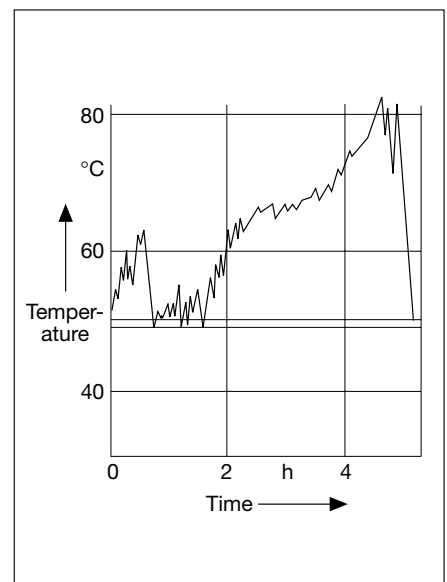
4: March of temperature as a function of time with failing grease lubrication. Test condition:

$n \cdot d_m = 200\,000 \text{ min}^{-1} \cdot \text{mm}$.

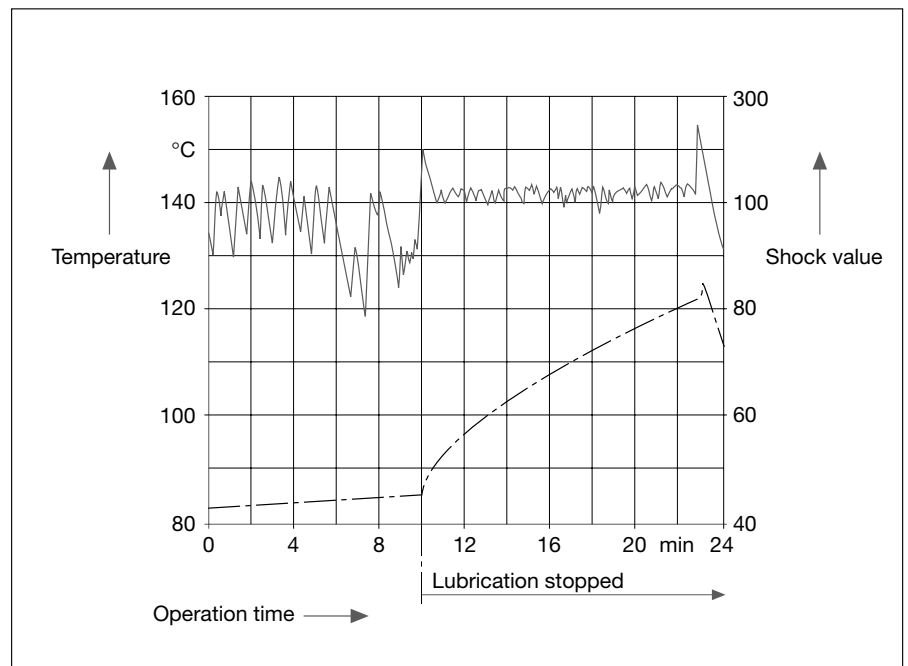
7: March of temperature and shock value as a function of time stopping lubrication. Spindle bearing B7216E.TPA; P/C = 0.1; n = 9000 min^{-1} ; Lubricating oil ISO VG100.

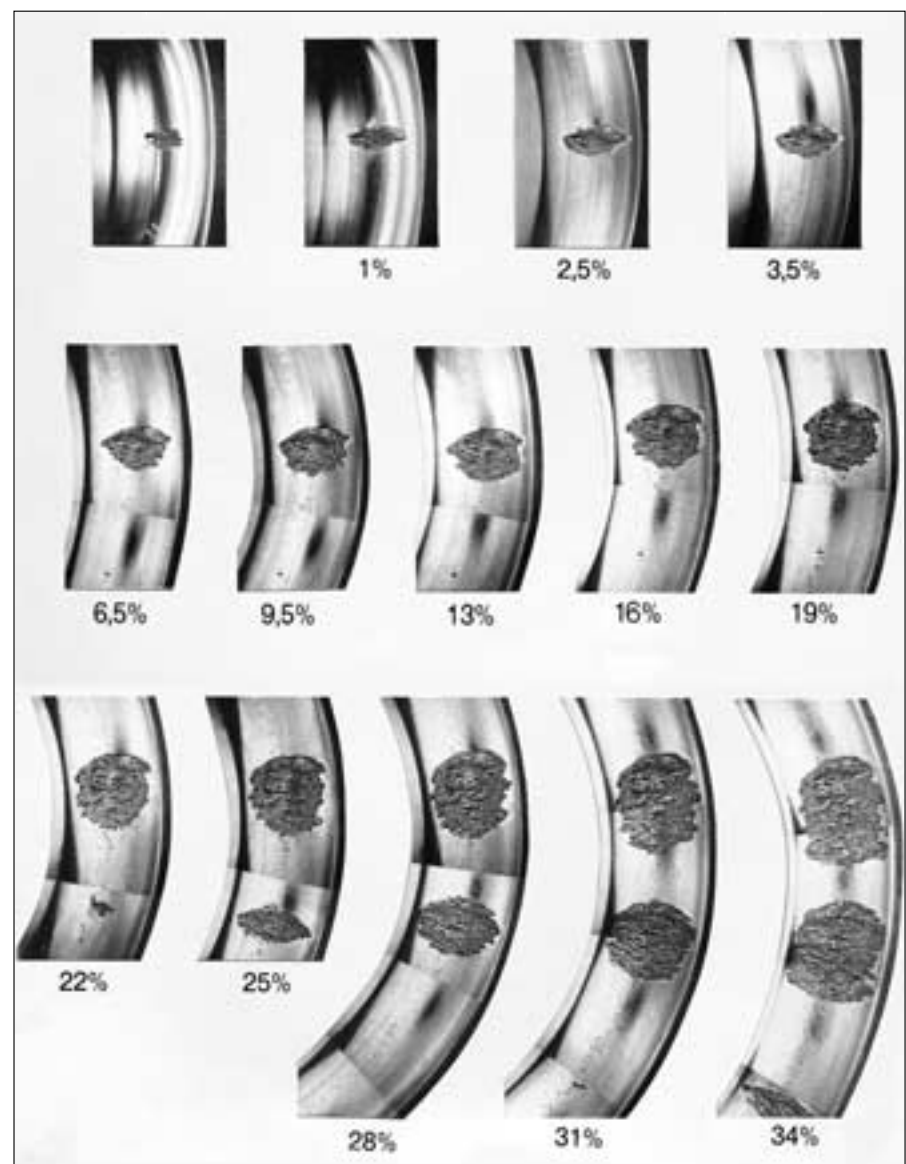
8: Development of fatigue damage on the inner ring raceway of an angular contact ball bearing. The periodic intervals between inspections from damage begin on, are given in percentage of the nominal life L_{10} .

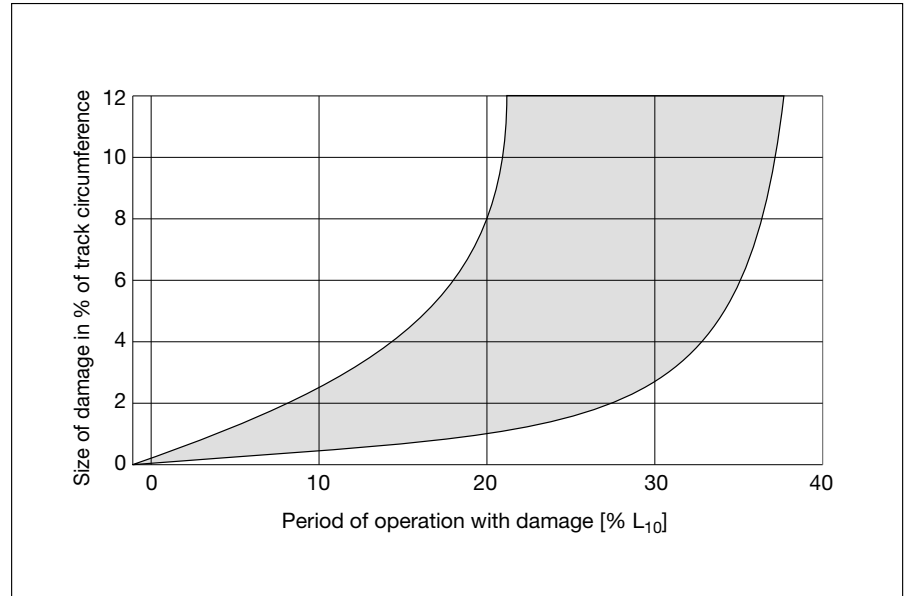
9: Size of damage based on the running time after damage recognition (when approx. 0.1% of track circumference is flaked)

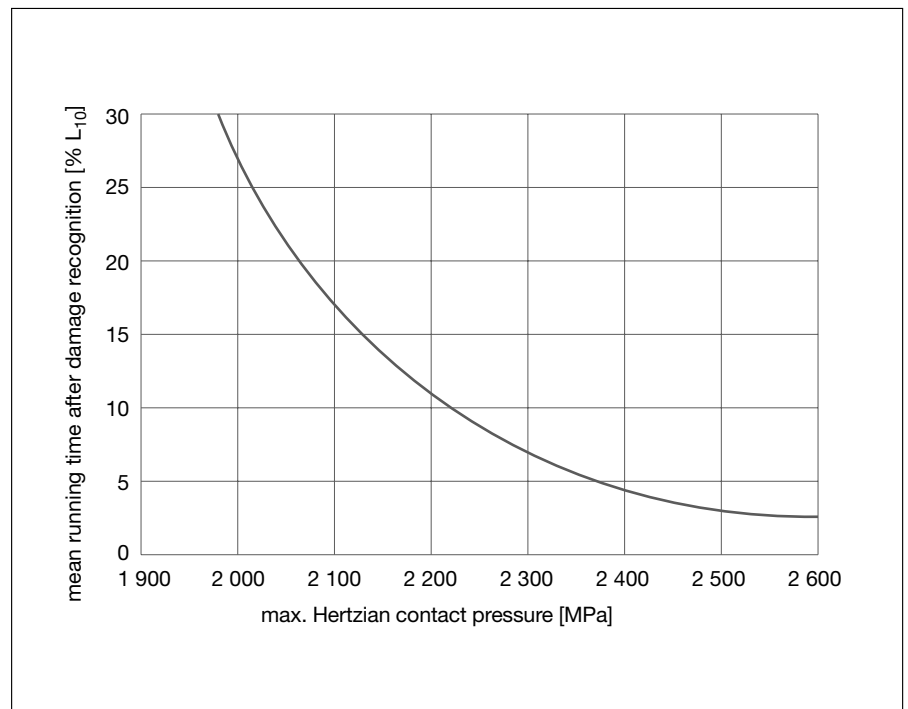
10: Mean remaining running time of angular contact ball bearings after recognition of fatigue damage based on stress condition until 1/10 of the track circumference is damaged. Operating condition prior to first signs of fatigue damage: Utmost cleanliness in EHD lubricating gap.

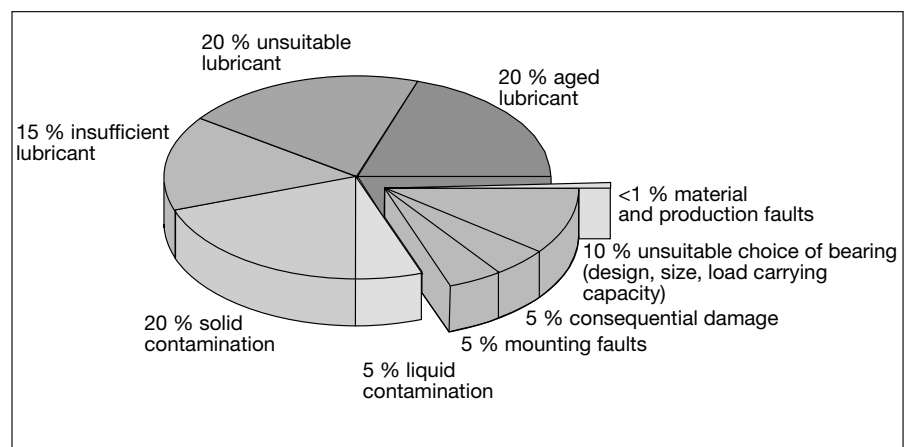
11: Causes of failure in rolling bearings (Source: antriebstechnik 18 (1979) No. 3, 71-74). Only about 0.35% of all rolling bearings do not reach expected life.

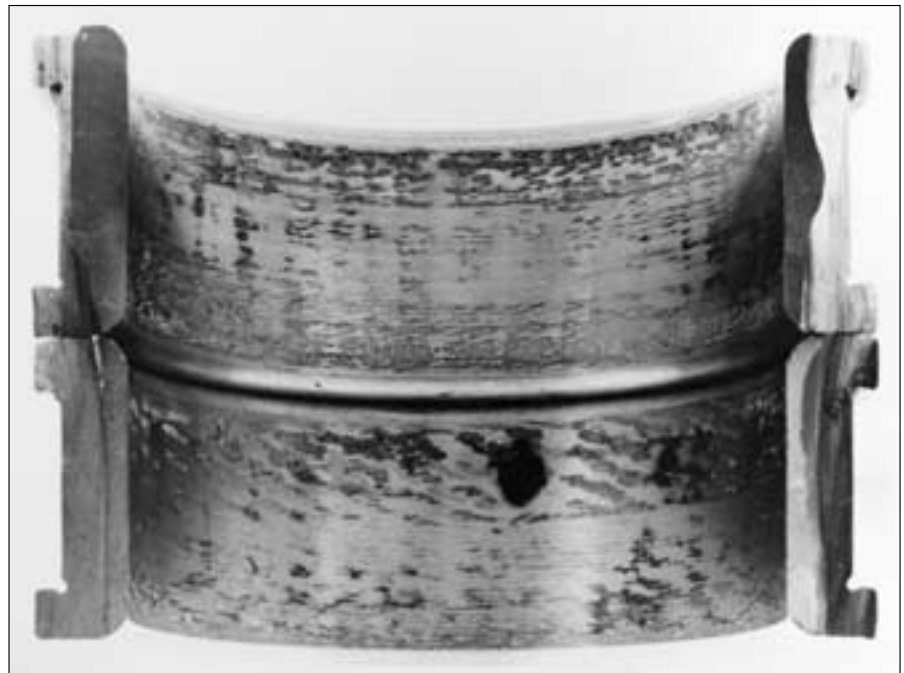
13: Fretting corrosion in bore of a cylindrical roller bearing inner ring with seat too loose

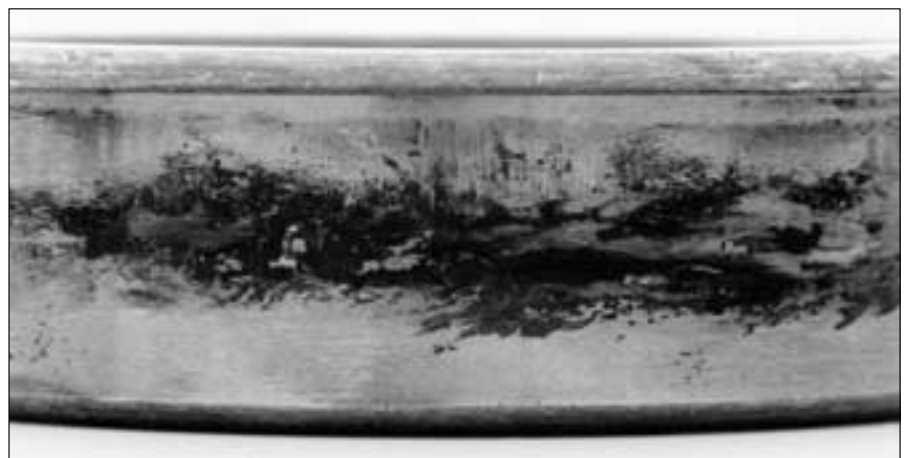
14: Fretting corrosion reveals the size of the load zone at the stationary outer ring

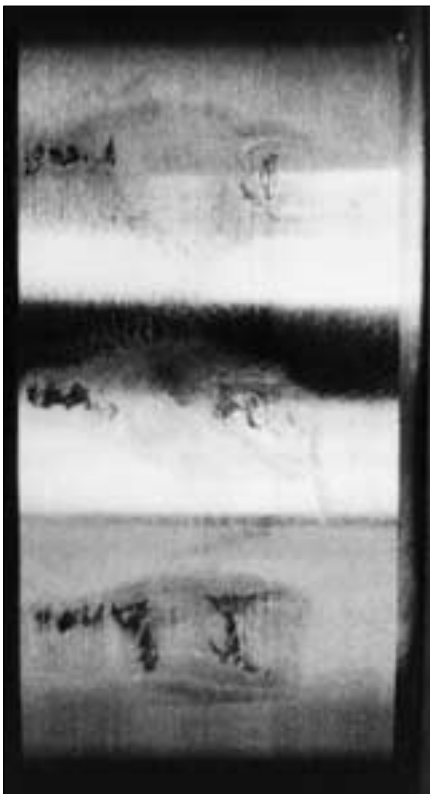
18: Outer ring outside diameter, fretting corrosion at "tough points" (e.g. ribs) in the housing

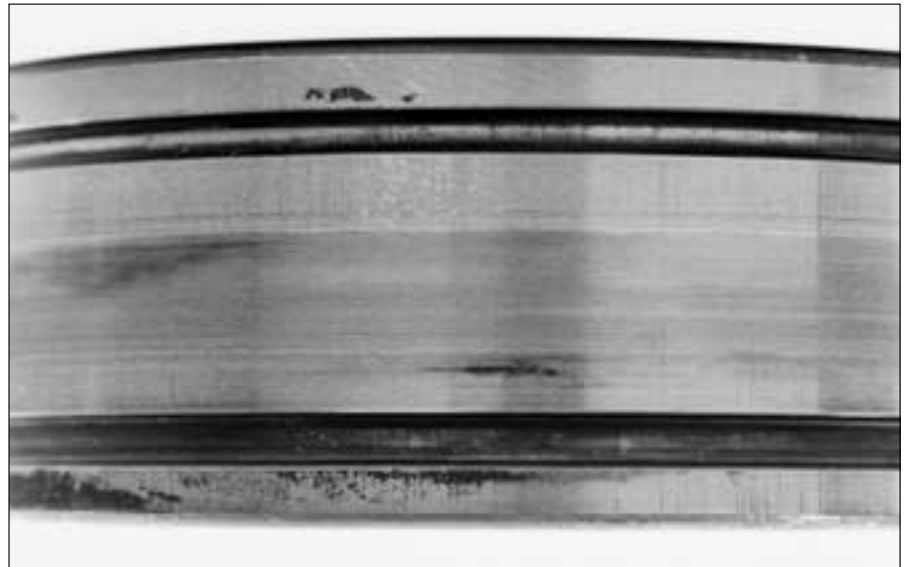
19: Outer ring outside diameter, only half its width supported

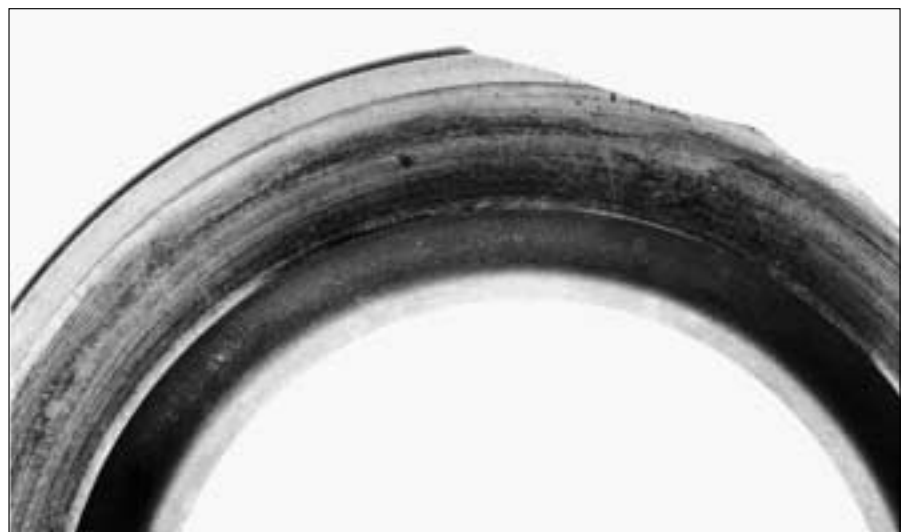
20: Lip fracture of a tapered roller bearing cone due to insufficient axial support of face

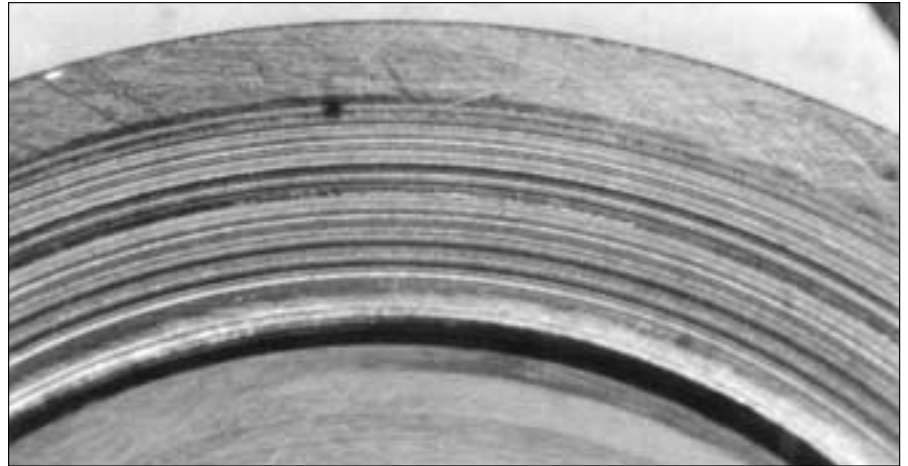
21: Circumferential scoring and cold welding at the faces due to grazing by a mating part

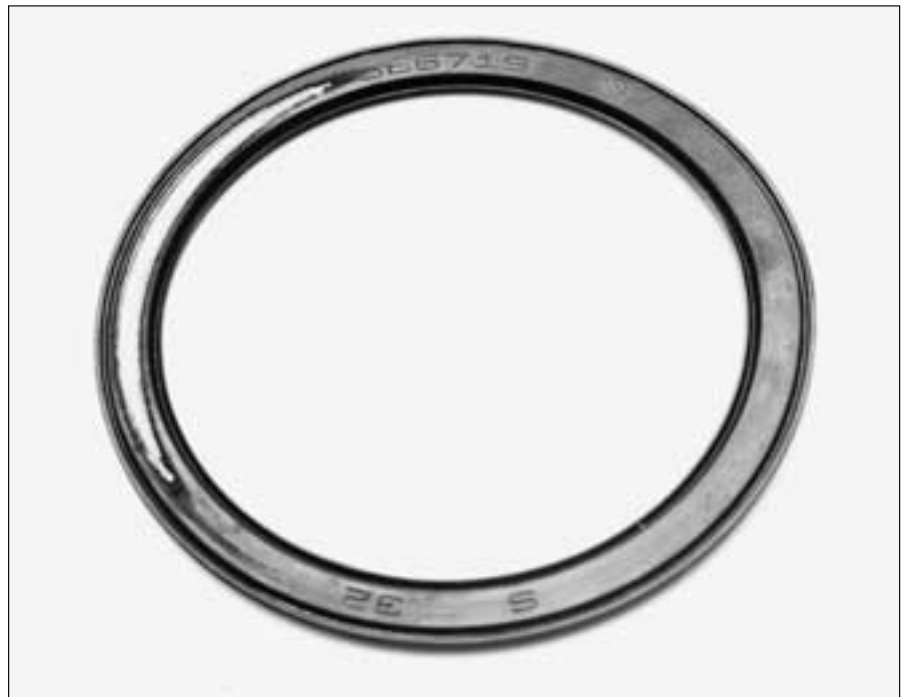
22: Seal damage due to lateral grazing

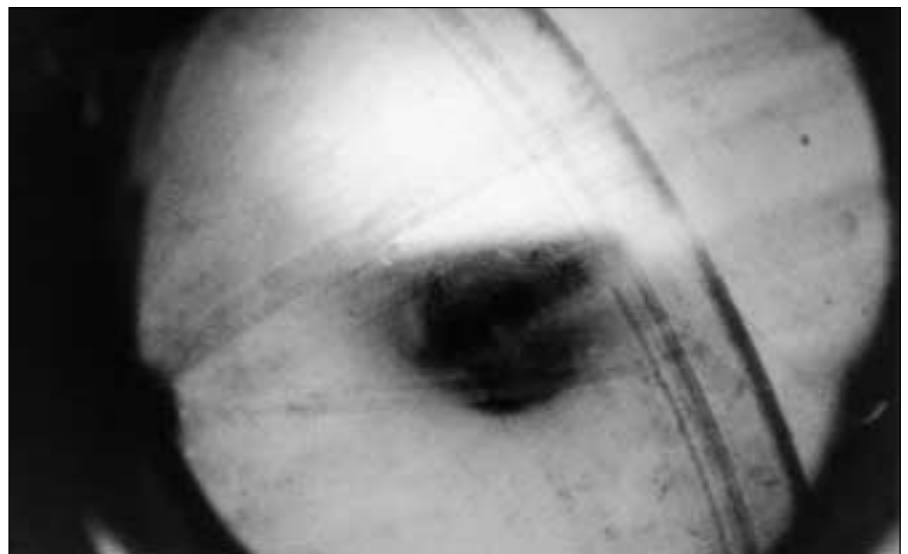
24: Ball with equatorial circumferential lines

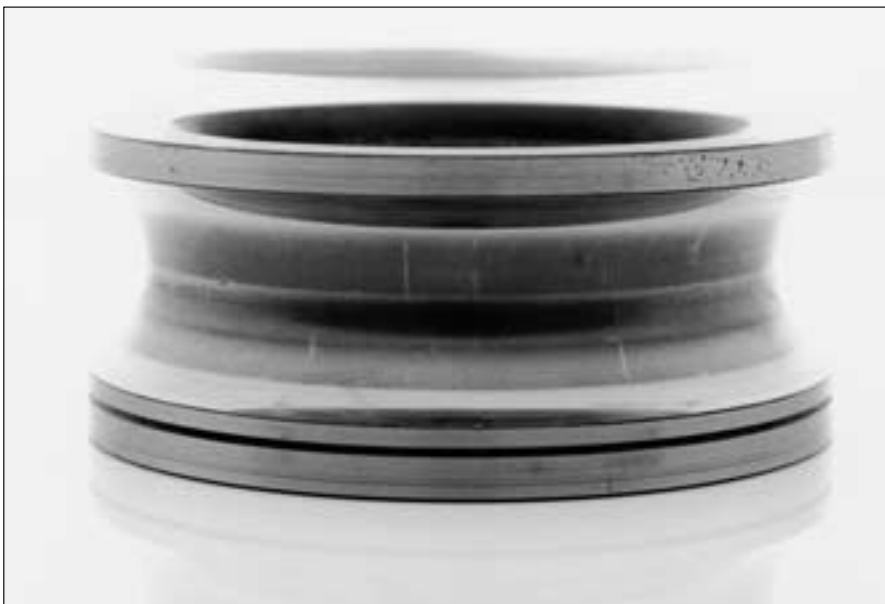
28: Track with surface wear

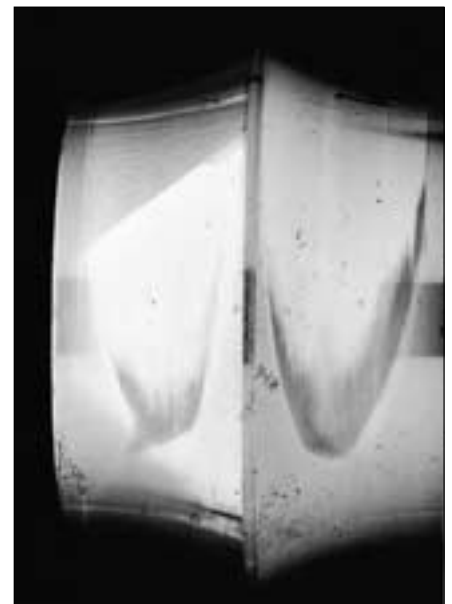
29: Pressure-polished track

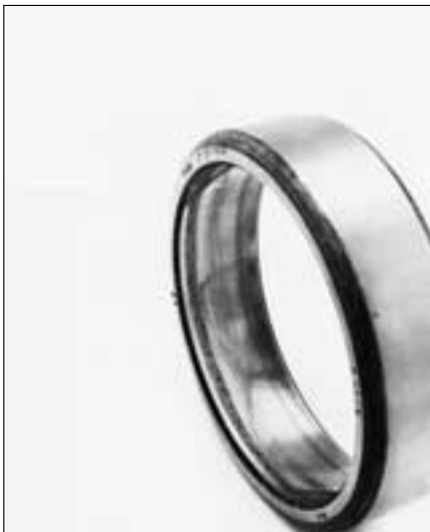
36: Flaking in one of the tracks on the outer ring of a self-aligning ball bearing caused by detrimental axial preload

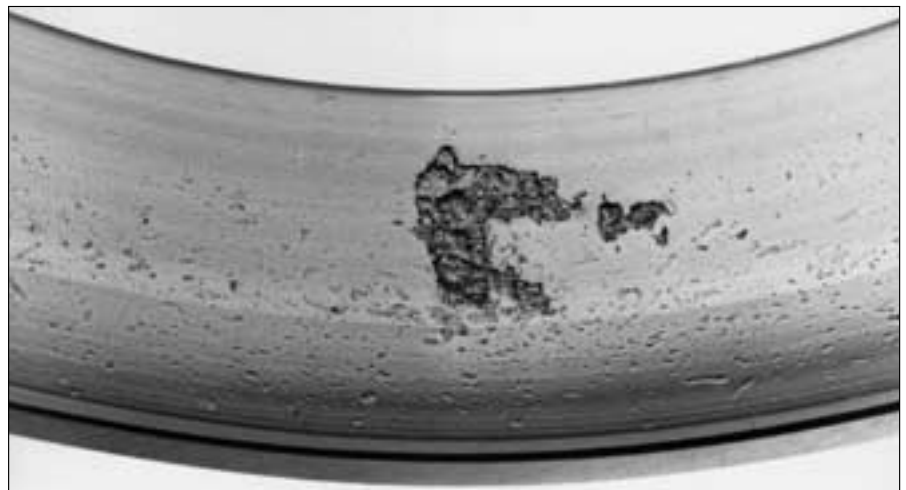
43: Fatigue damage in the outer ring raceway of a tapered roller bearing

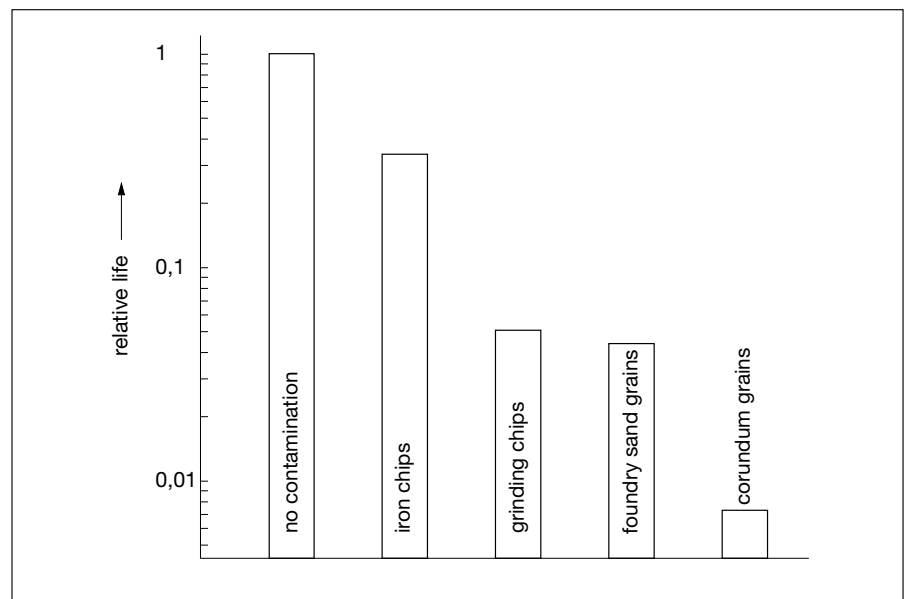
44: Reduction in life due to different contaminants

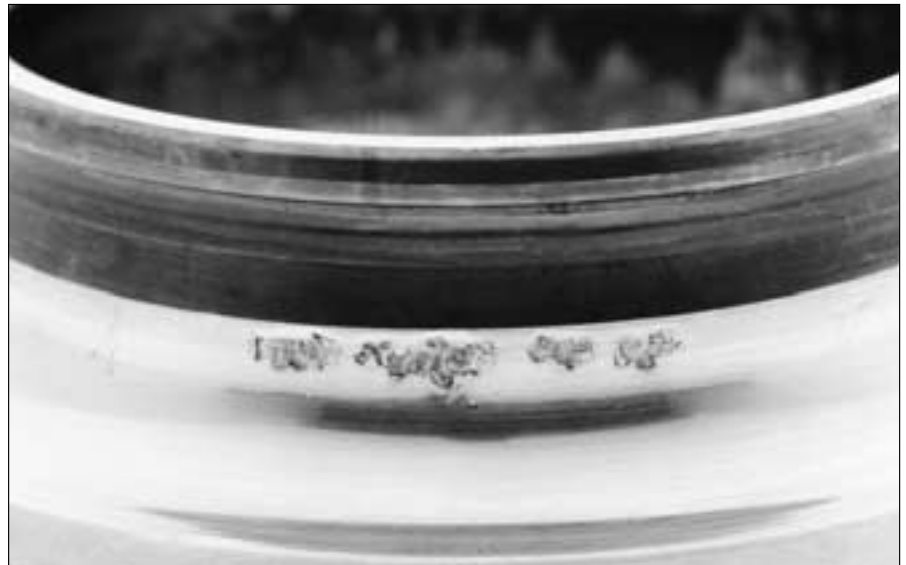
46: Fatigue damage in groove bottom of an angular contact ball bearing's inner ring as a result of insufficient adjustment force

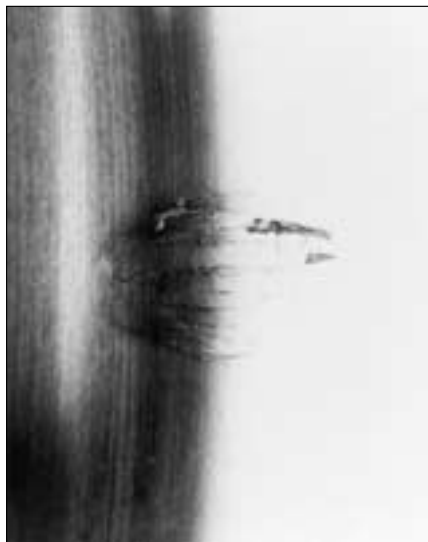
49: Micro pittings

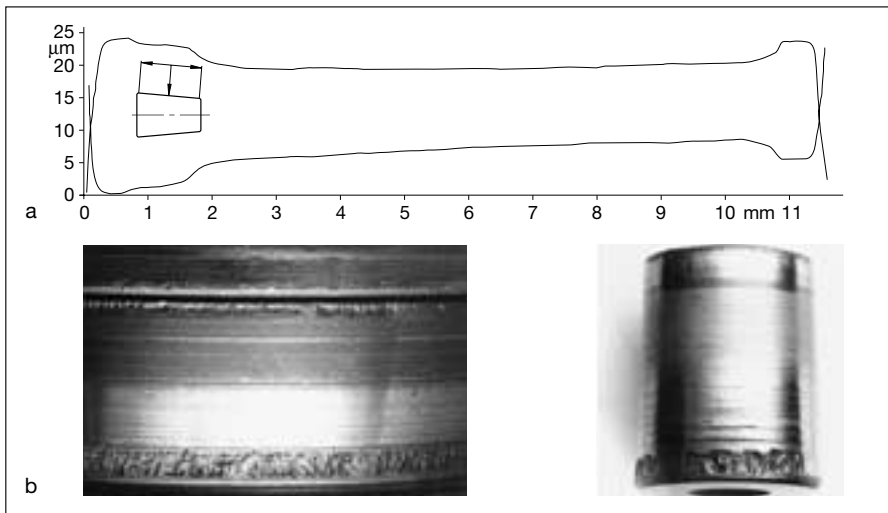
51: Wear in diverse areas can change the geometry of the components in rolling contact to such an extent that local overload leads to fatigue

a: Cross profile of a roller;

b: Inner ring raceway and roller with fatigue damage.

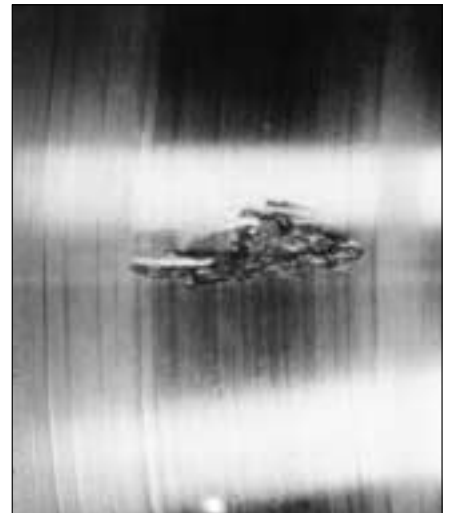
52: Failure mechanism as in fig. 51 but with wear of the raceway edges, cross profile of the roller see fig. 69.

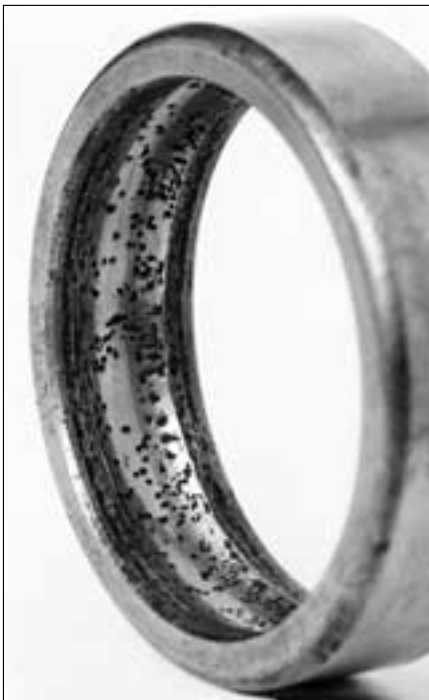
53: Corrosion of the outer ring of a deep groove ball bearing, the corrosion protection of which was destroyed by humidity

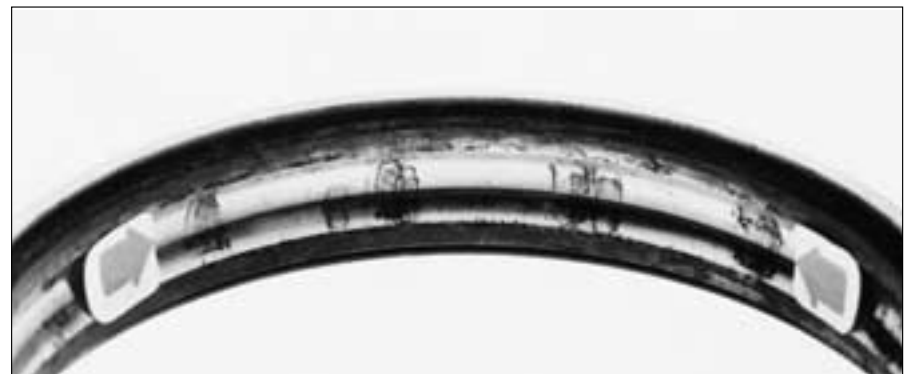
54: Corrosion pits in the raceway at rolling element pitch

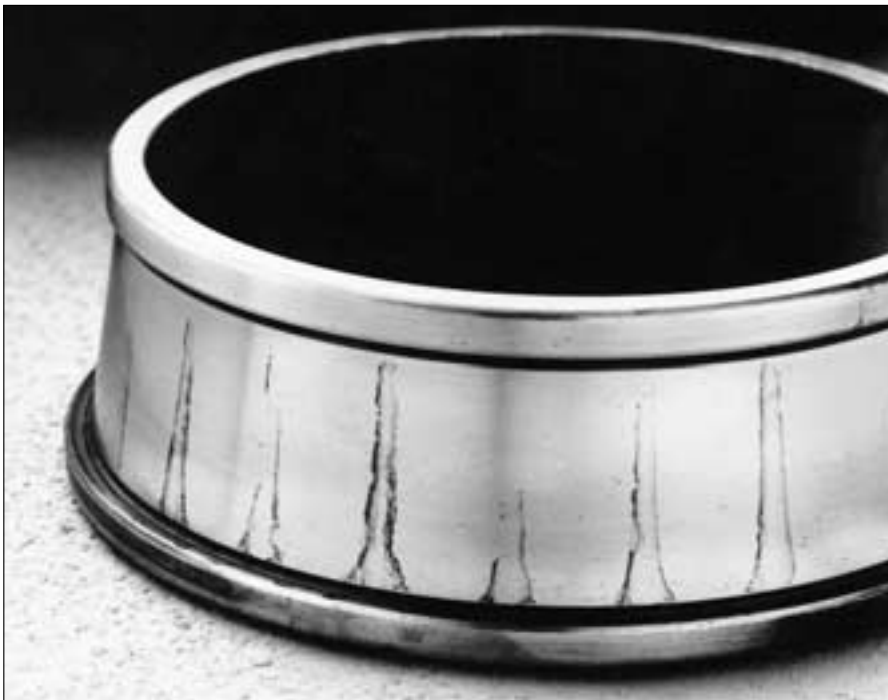
55: Surface damage due to attack of aggressive media. The etching pits are usually black.

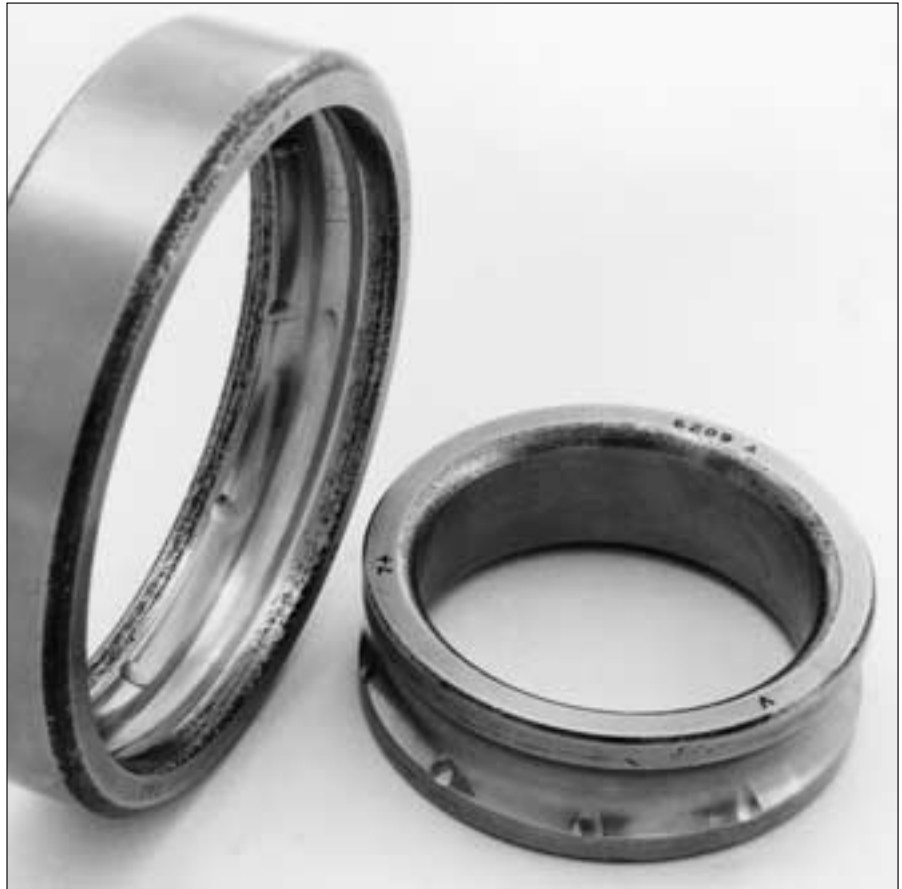
58: Ball indentations in the shoulders of a deep groove ball bearing. The mounting tool was attached to the ring with a loose fit and the forces were therefore applied via the balls.

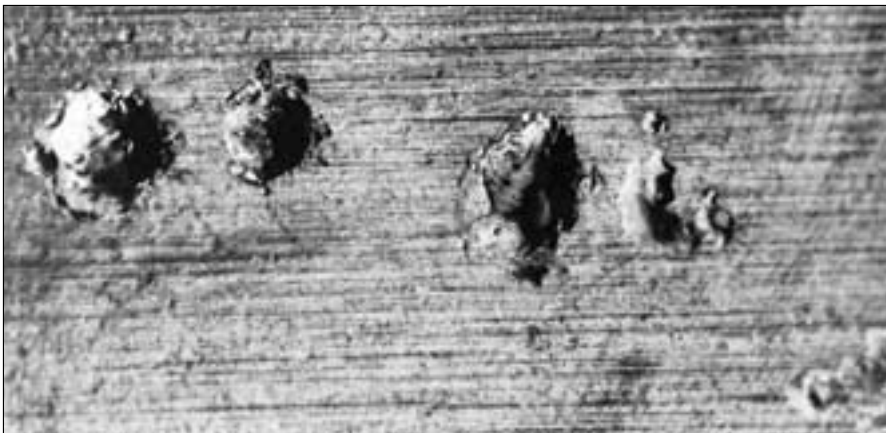
59: Current sparkover led to the formation of craters in the raceway of a cylindrical roller bearing.

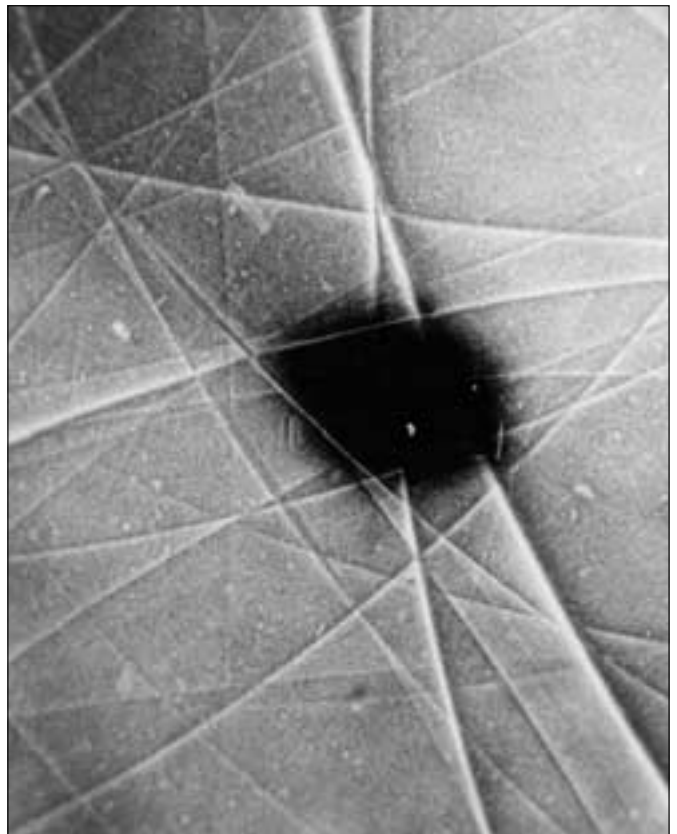
62: Ball with "woolen balls" of notches caused by long-term changing load

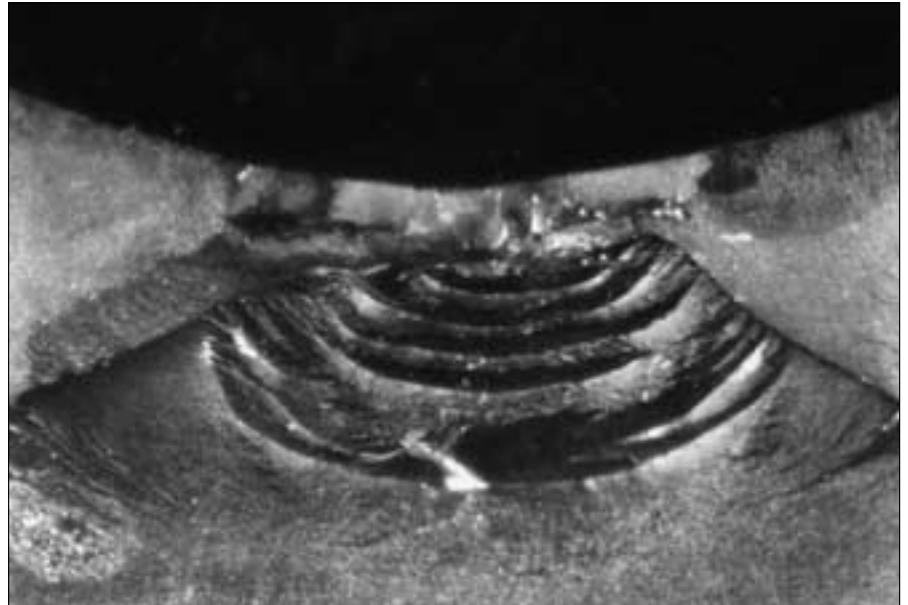
63: Outer ring fracture of a deep groove ball bearing in the axial direction as a result of fatigue

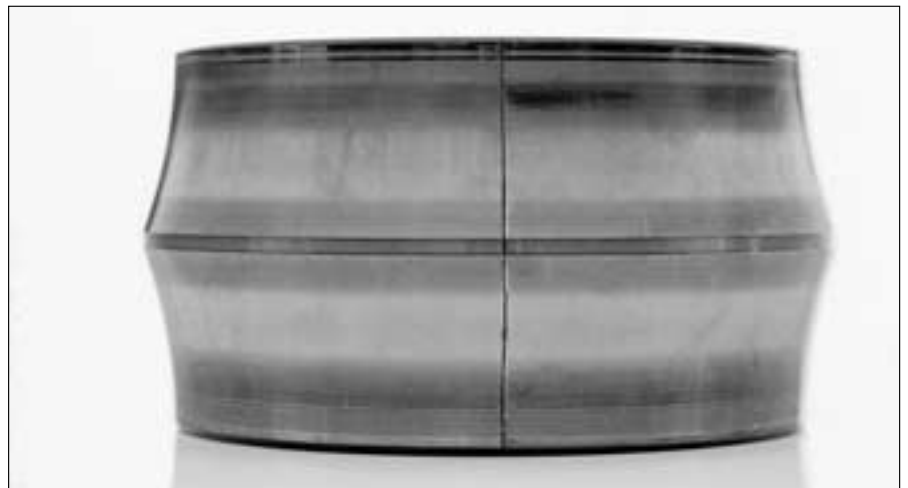
64: Axial through crack of a spherical roller bearing's inner ring

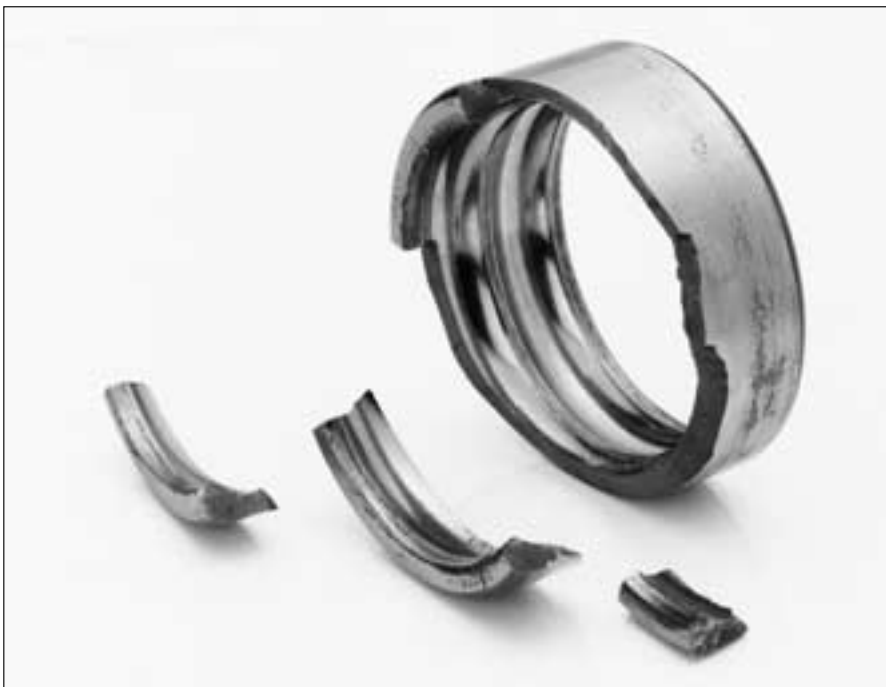
65: Crack in outer ring in circumferential direction

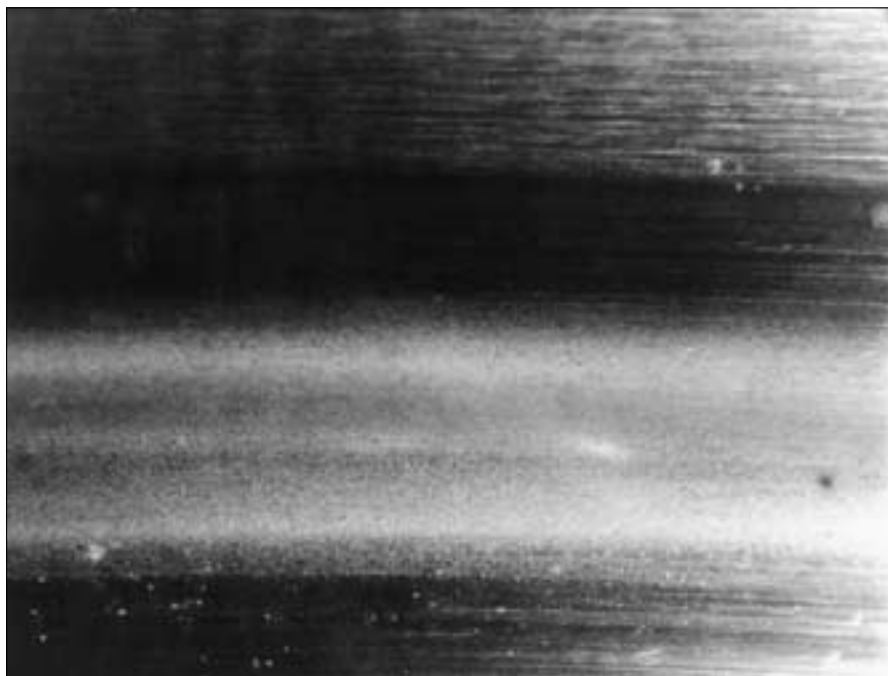
66: Worn, roughened raceway

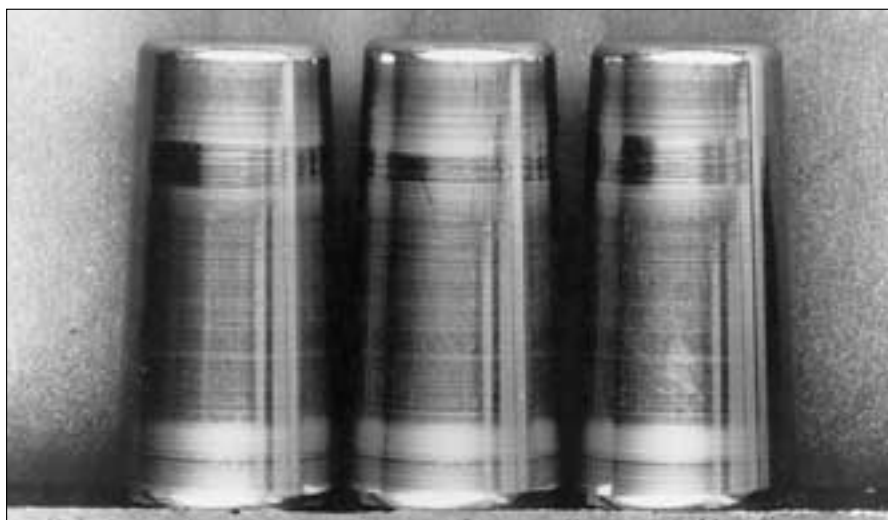
67: Wear traces can usually first be detected on the surfaces of the rolling elements

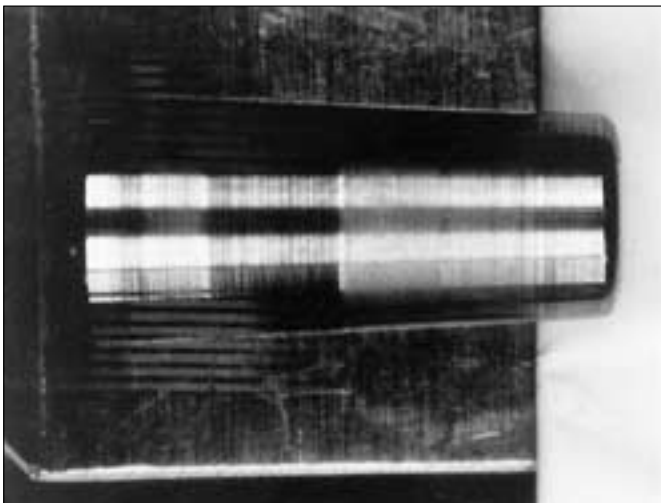
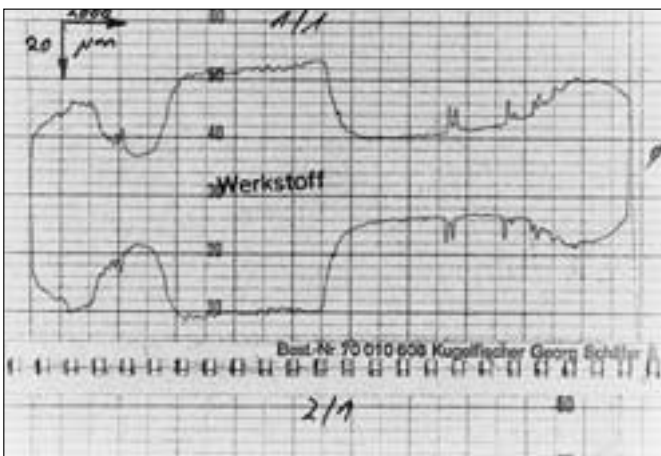
68: Formation of stripes as a result of wear in certain areas.
a: Roller

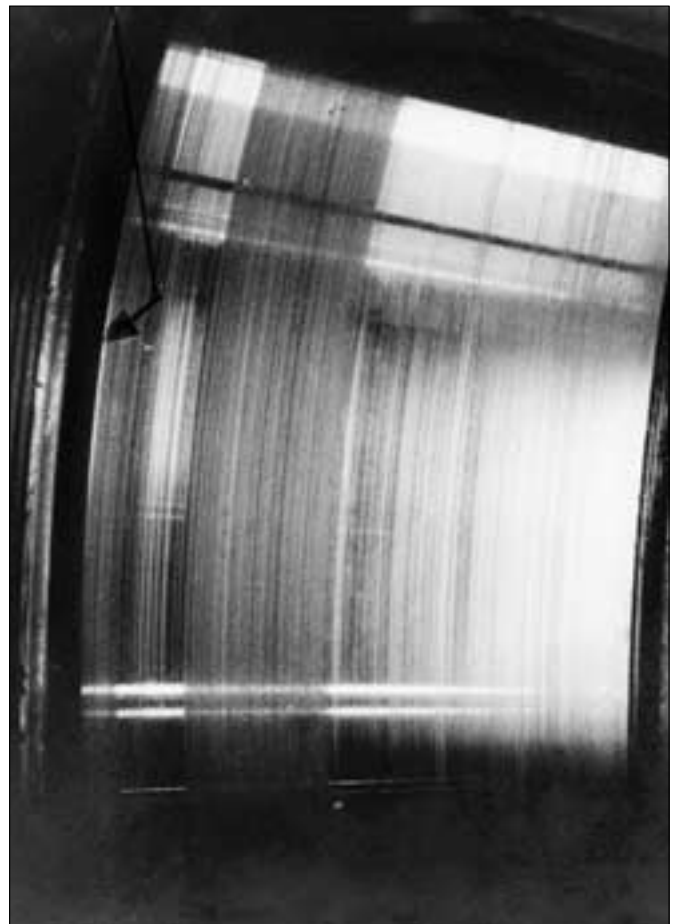
b: Raceway

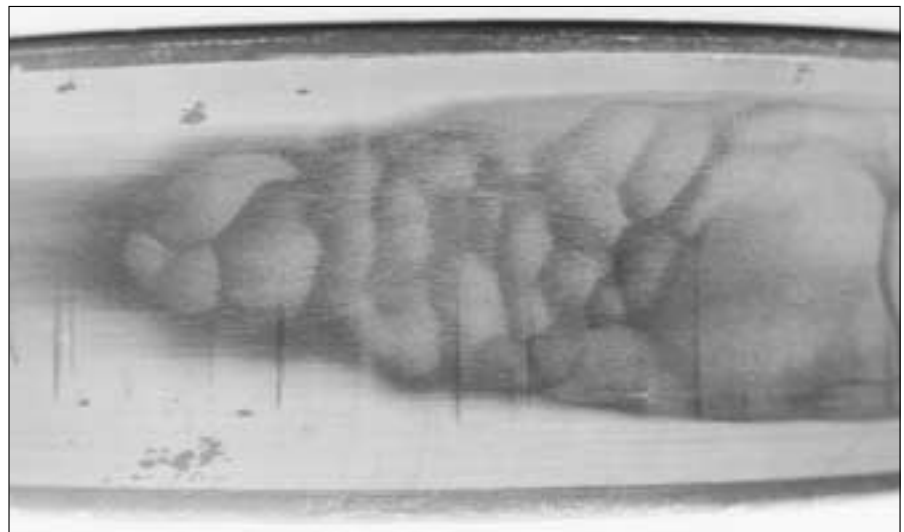
74: Slippage tracks on cylindrical rollers

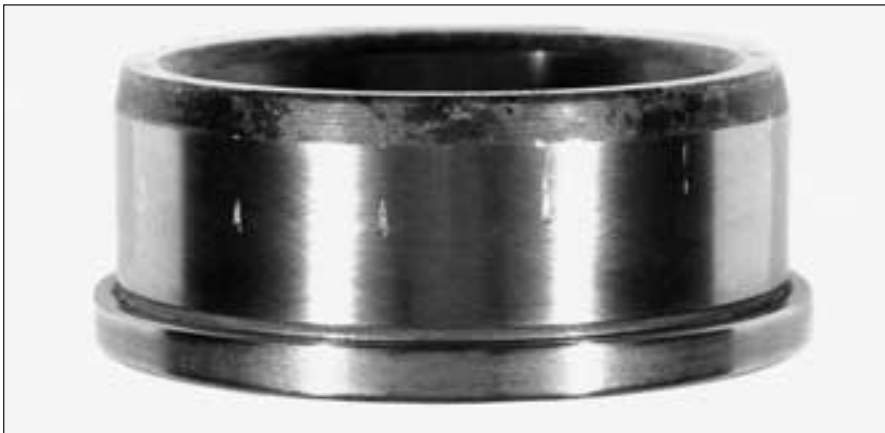
76: Score marks in the raceway of a cylindrical roller bearing inner ring caused by out-of-square insertion into the rolling element set

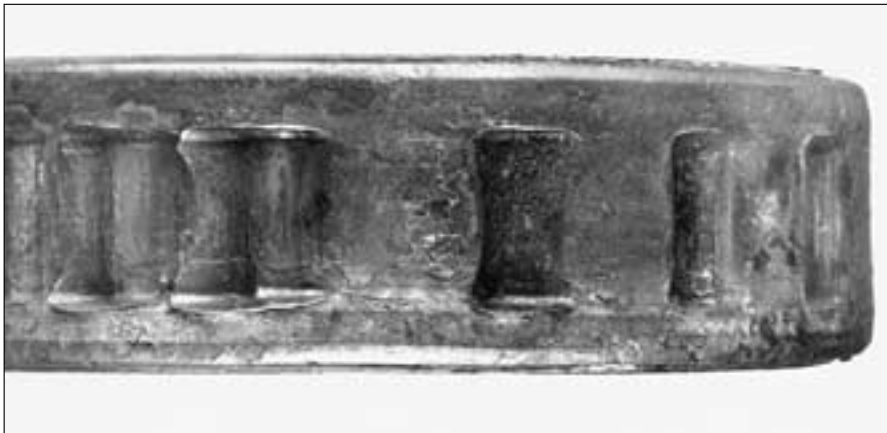
77: The rollers left deep impressions in the raceway of a seized, overheated cylindrical roller bearing.

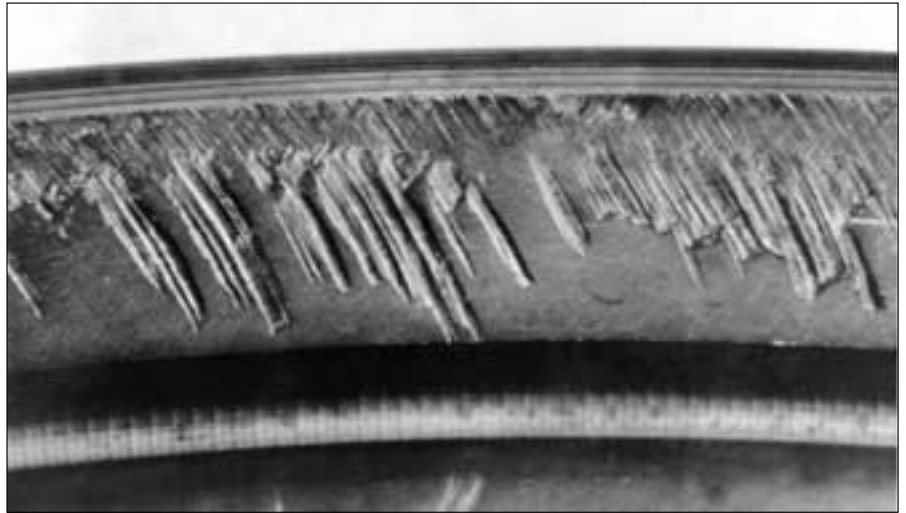
81: Skewing rollers caused seizure marks at the lip when in contact with its edges.

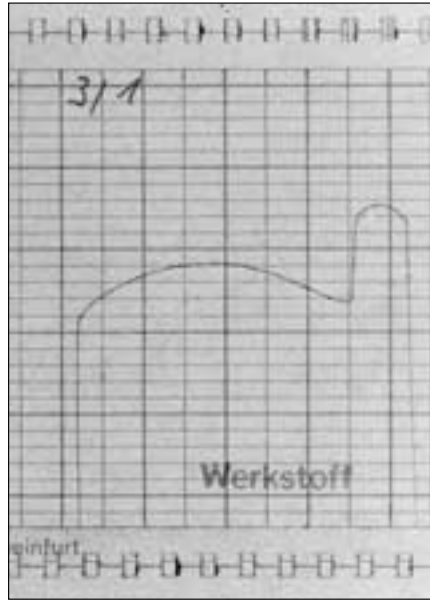
83: Cross profile chart of a worn tapered roller face

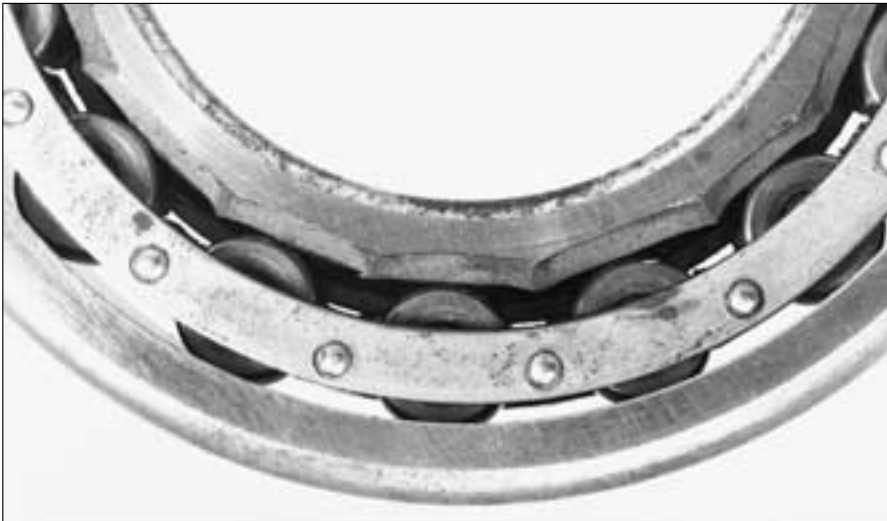
85: Lip broken off a barrel roller bearing. The inner ring was driven onto the shaft with a hammer.

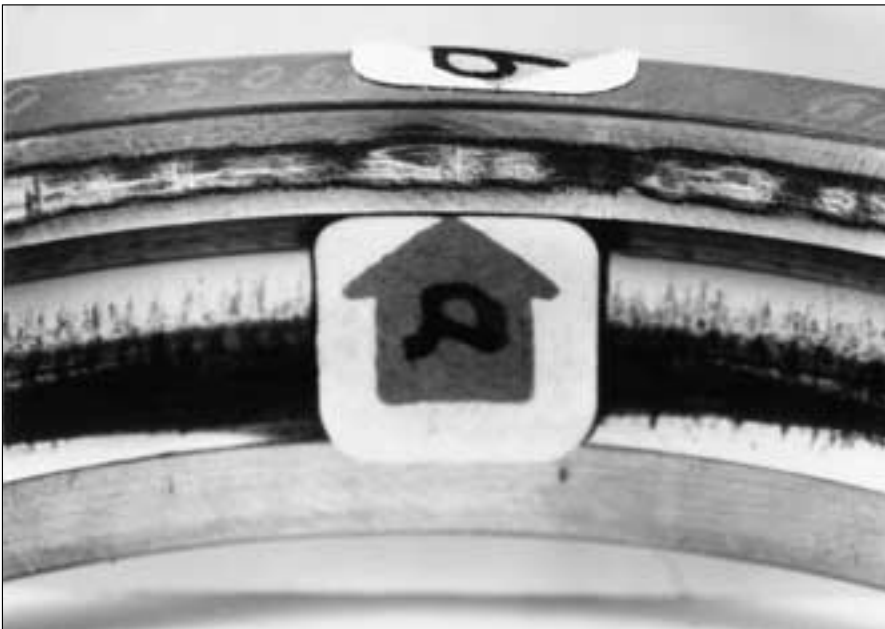
86: Bad contact marks on the cage guiding surface of an outer ring lip with smeared on material
