Rolling Bearing Damage

Recognition of damage and bearing inspection

Publ. No. WL 82 102/2 EA

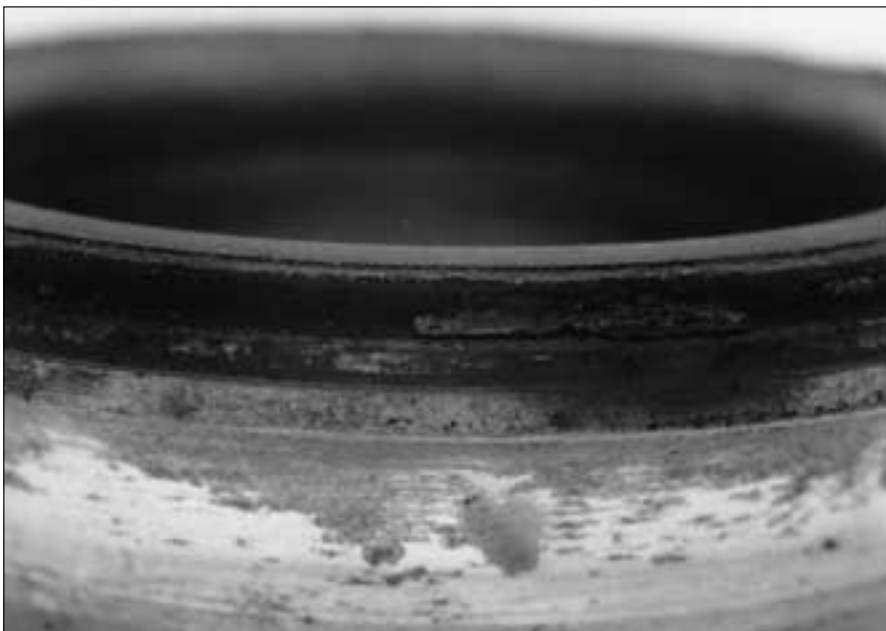
87: Corrosion in the area of the sealing track at the lip of an angular contact ball bearing

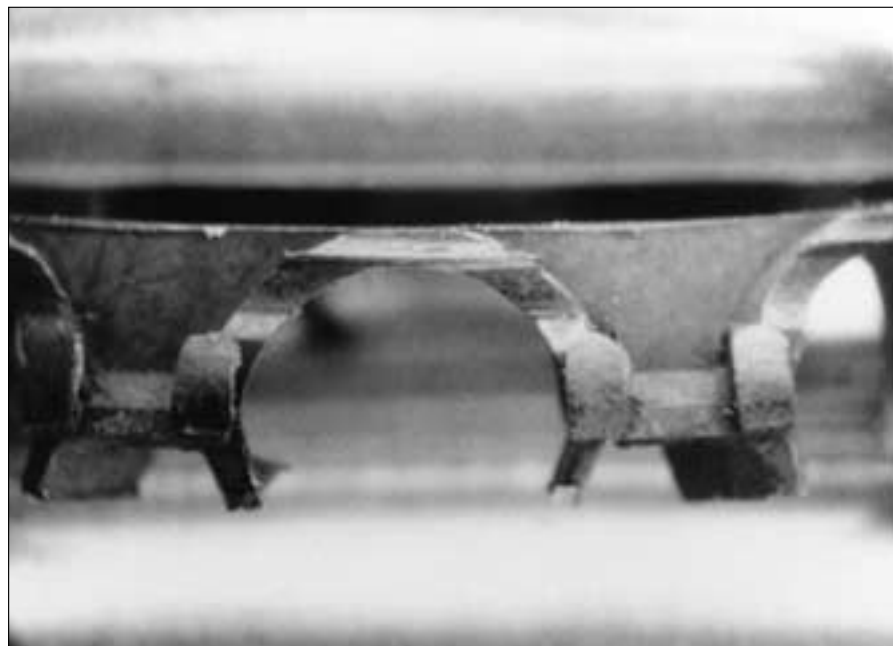
89: Wear of cage outside diameter due to grazing at the bearing outer ring

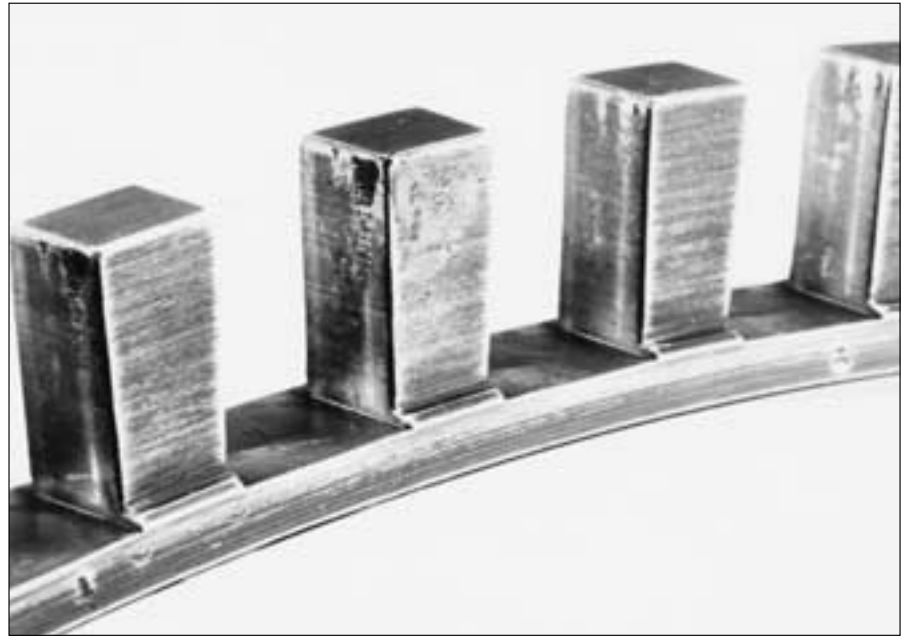
90: Diagonal wear in cage pockets of roller bearings

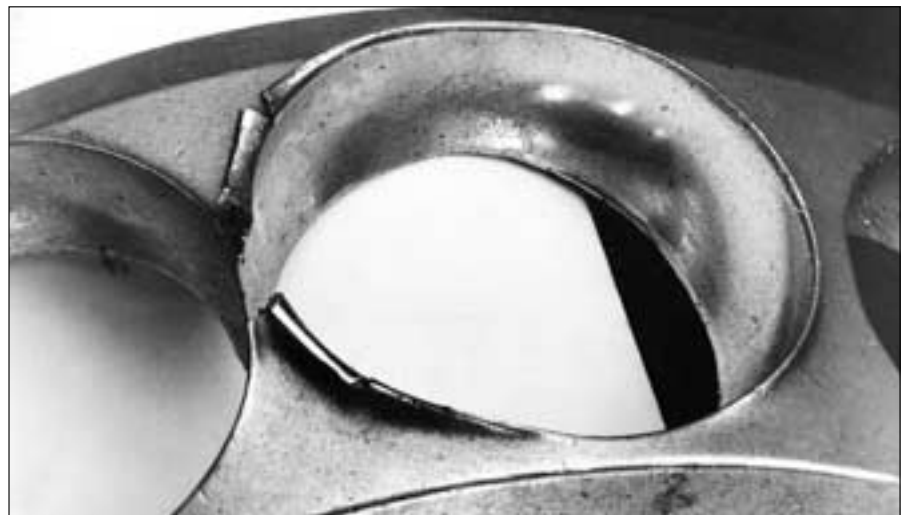
91: Bearing rings tilting towards one another led to high constraining forces between balls and cage which, in turn, led to web fracture.

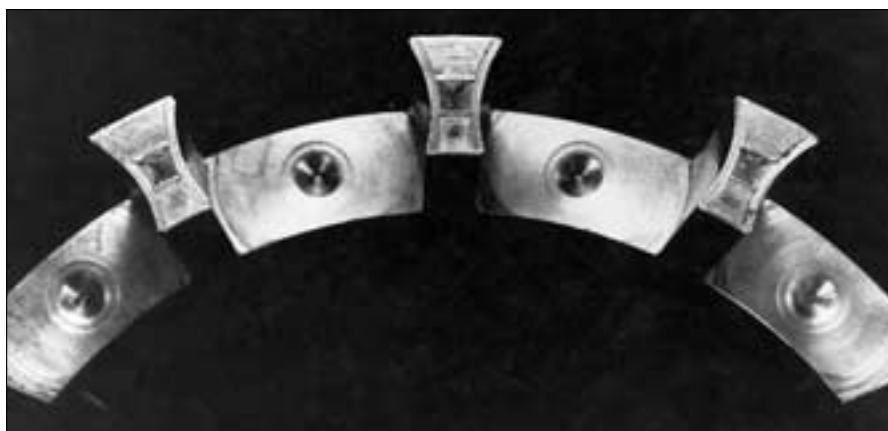
92: Fractured cage-rivet connections may result from vibration stress.

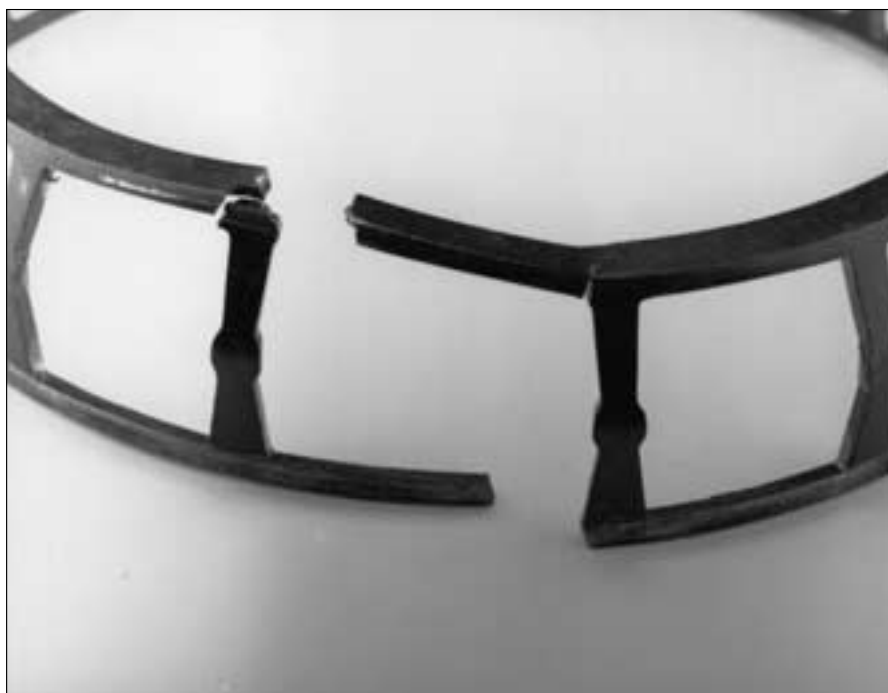
93: Disruptive fracture at the side edge of a spherical roller bearing cage

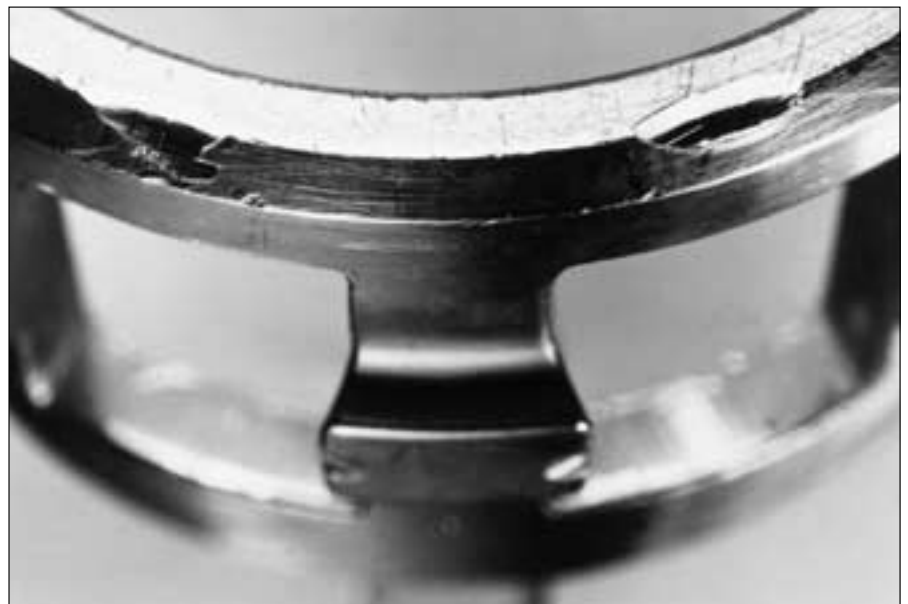
95: Metal cage with dents

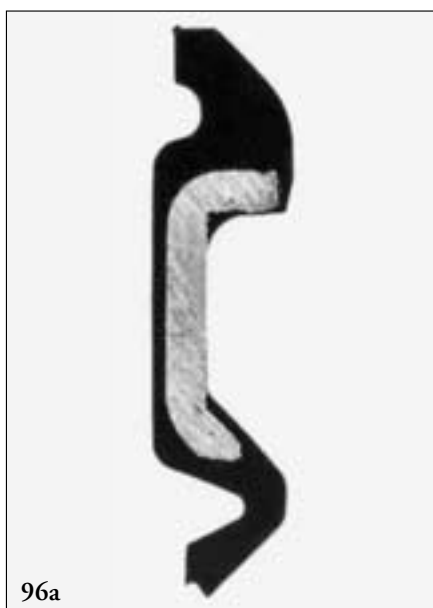
96: Cross section of a seal.

a: new sealing lip; b: worn sealing lip

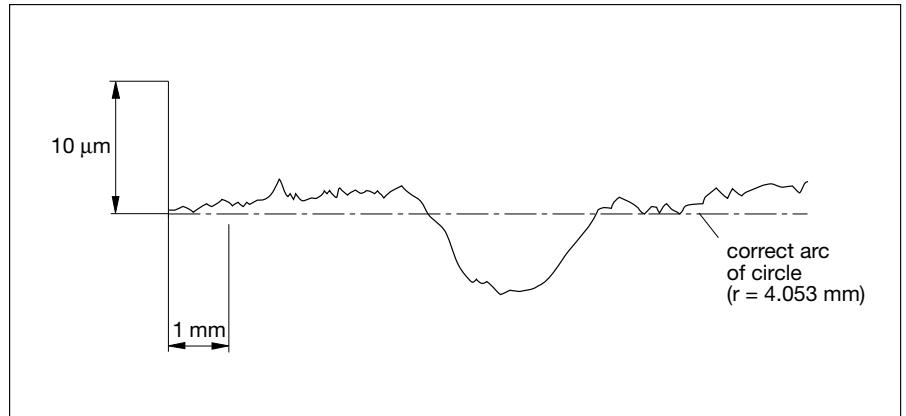
100: Profile of a deep groove ball bearing raceway with wear groove (raceway curve compensated for by measuring device)

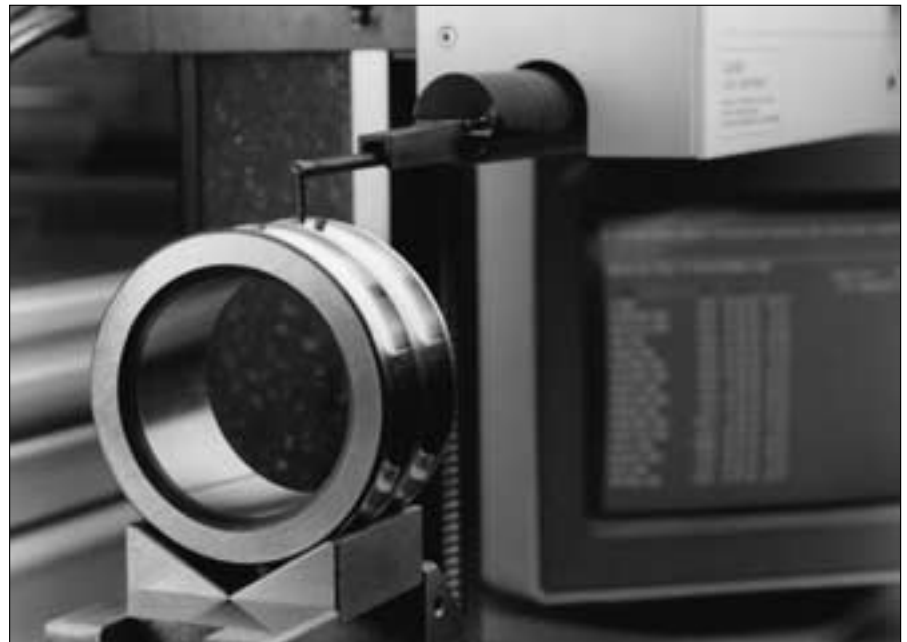
101: Form Talysurf

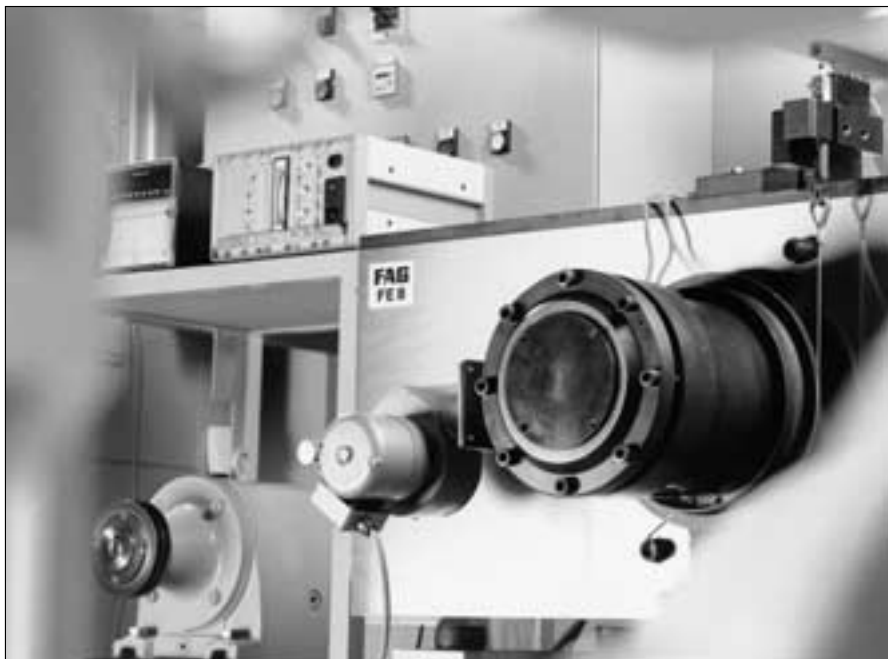
107: Test rig for determining lubricant quality

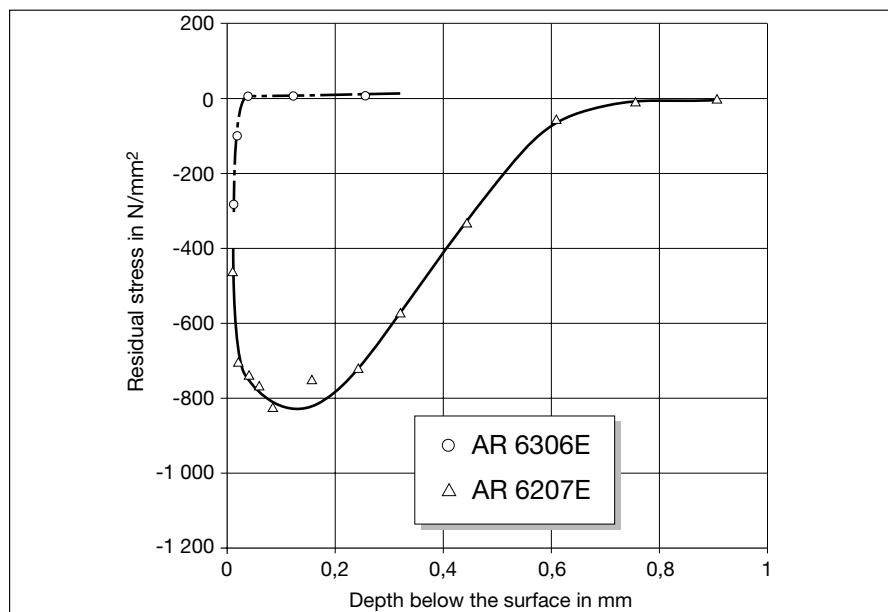
110: Residual stress pattern as attained from an X-ray micro structure analysis; high tangential force portion in outer ring 6207E, no increased stress in reference bearing 6303E

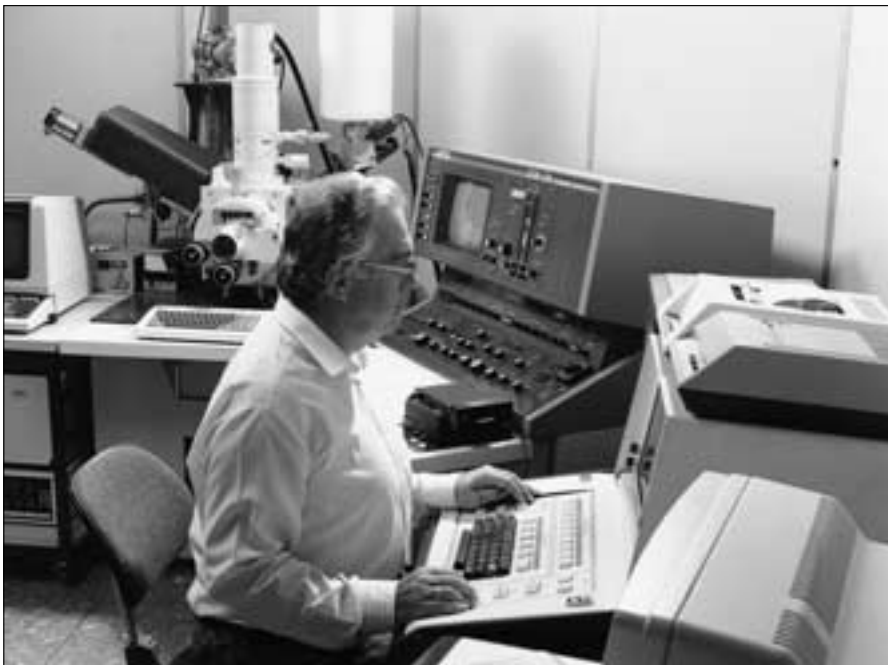
111: Scanning electron microscope

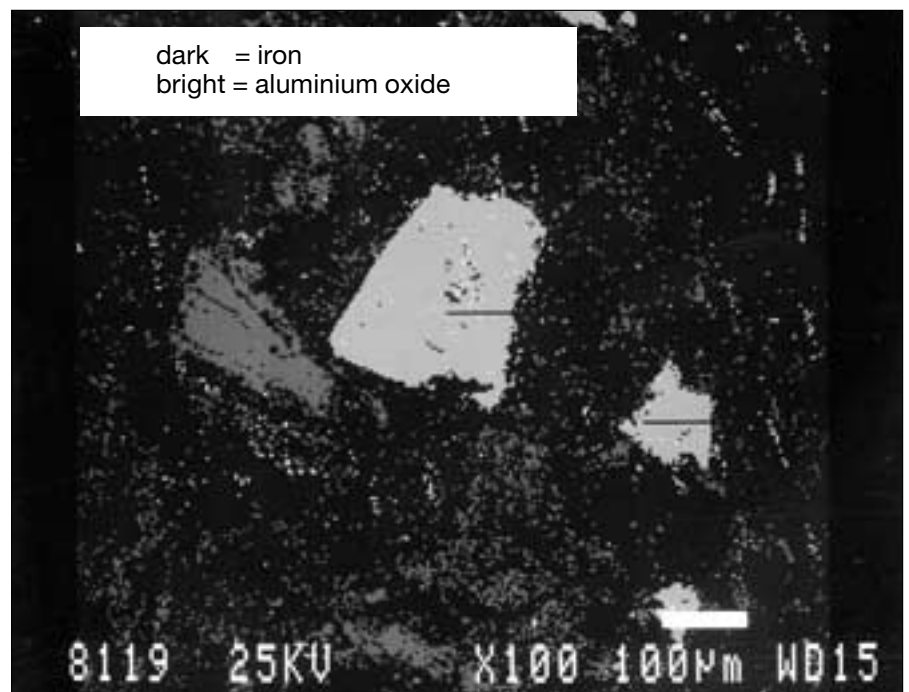
113 b: Material composition of foreign particles

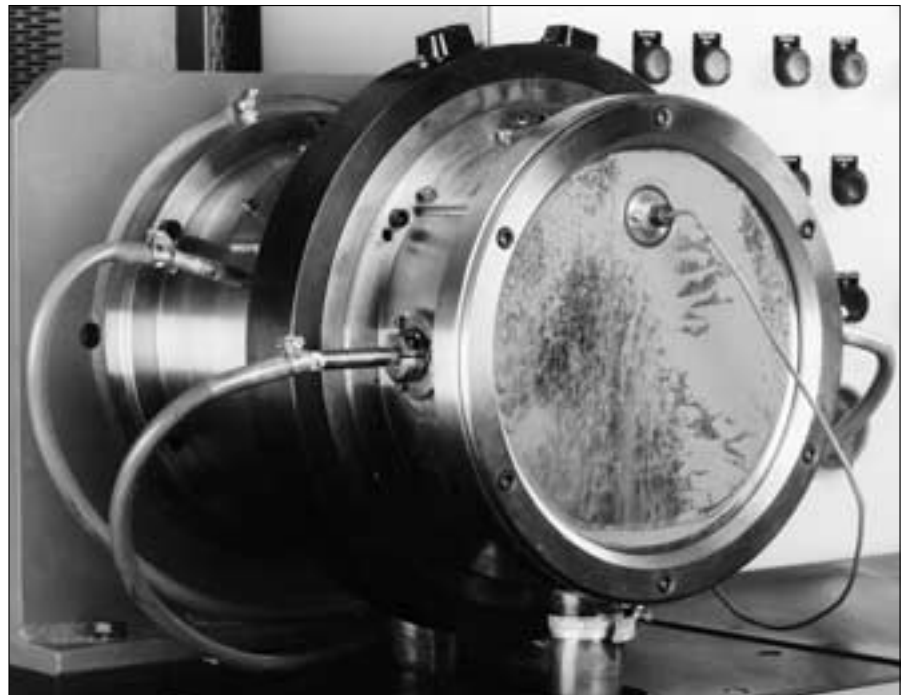
114: Test rig for inspecting the efficiency of rolling bearing seals

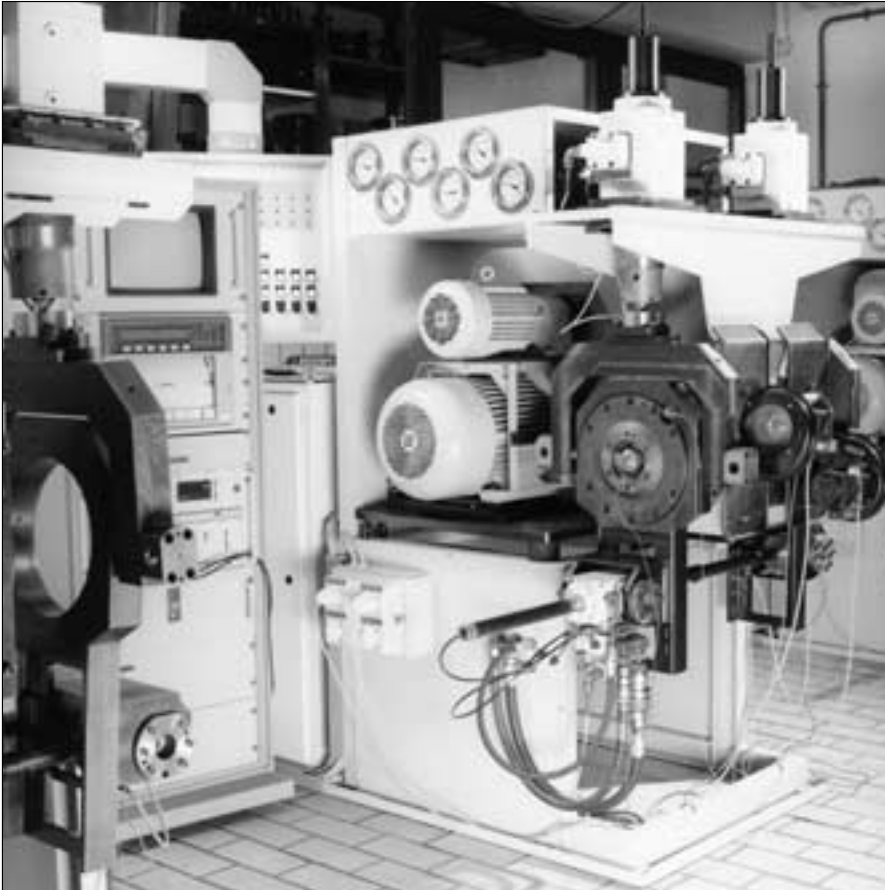
115: Test rig for simulating operating stress of car wheel bearings

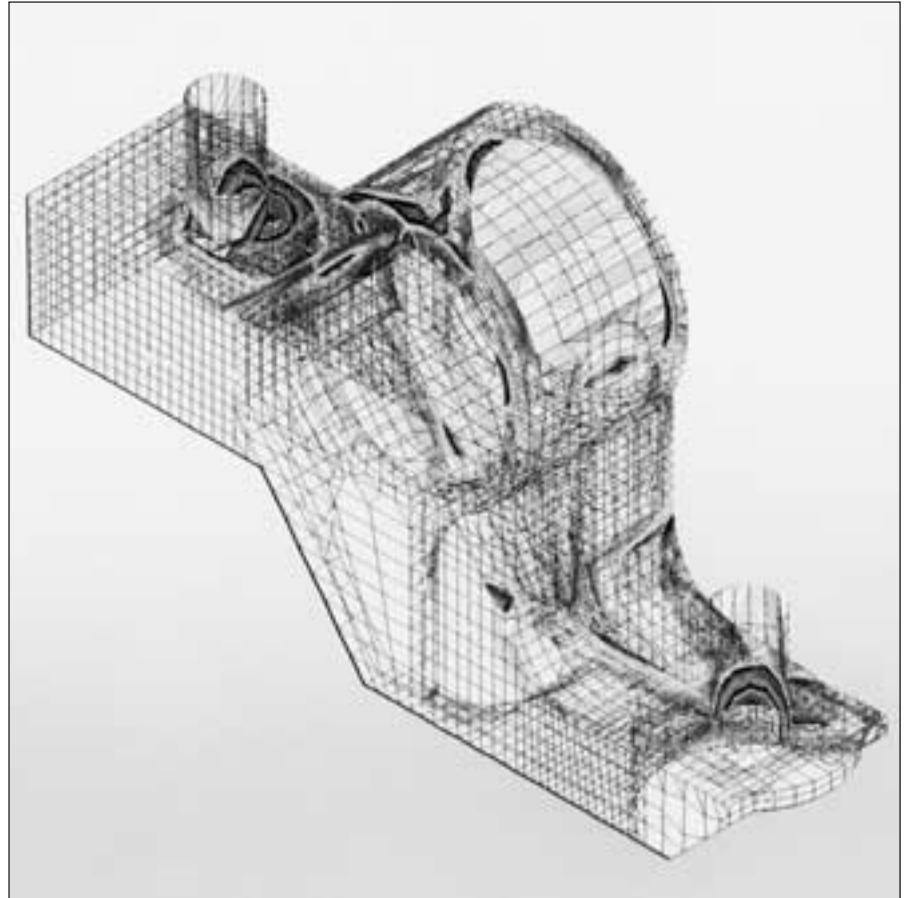
116: Calculation of stress on a journal roller bearing housing by means of the Finite Element Method (FEM)
